## PORT OF FLEETWOOD

### NOTICE to MARINERS 11 of 2016 Channel constant

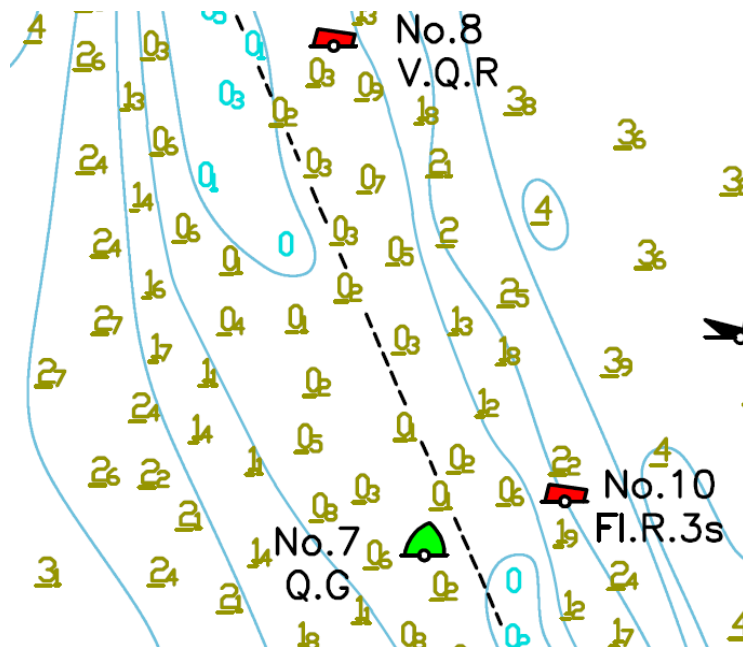
**Mariners are hereby advised** that following survey the controlling depth for the Fleetwood Channel between the Fairway and No.20 buoys lays in the vicinity of the No. 8 & 10 buoys where the channel dries up to 1.9m above Chart Datum.

This depth is to be found just south of the No.10 buoy.

Mariners are requested to ensure that they allow an adequate under keel clearance, appropriate to their vessel, especially when navigating over the low water periods.
